I-35W Bridge Collapse

S. Hao, Ph.D., M.ASCE¹

DOI: 10.1061/(ASCE)BE.1943-5592.0000090

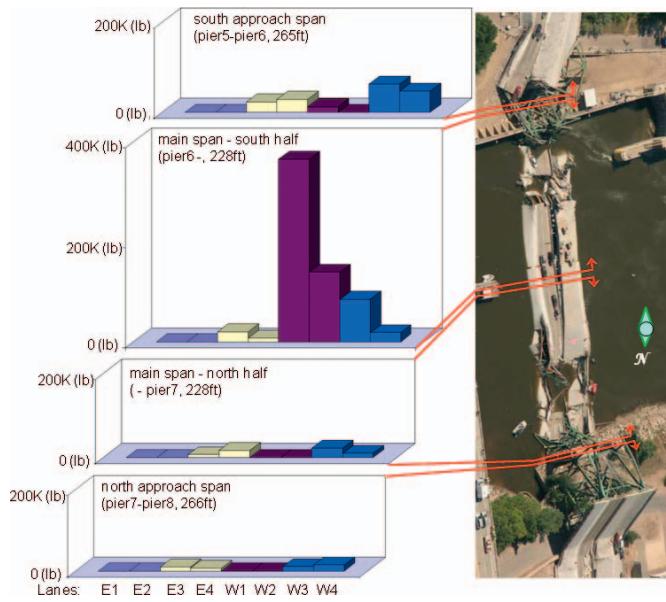
According to the National Transportation Safety Board’s [National Transportation Safety Board (NTSB) 2008a,d] investigation, roadway construction was underway on the deck-truss portion of the bridge, while four of its eight lanes were closed because of parked machineries and stock-piled paving materials on the bridge at the time of the collapse (see Fig. 1). There were also at least two recorded major rehabilitations done to the bridge previously, one in 1977 and another in 1998. As part of these rehabs, the average thickness of the concrete deck was increased

Fig. 1. (Color) Live load on each lane from east to west (left to right in the figure) over the four parts of the I-35W deck-truss spans, respectively, at the moment of collapse. Data were collected from National Transportation Safety Board (NTSB) (2008b).

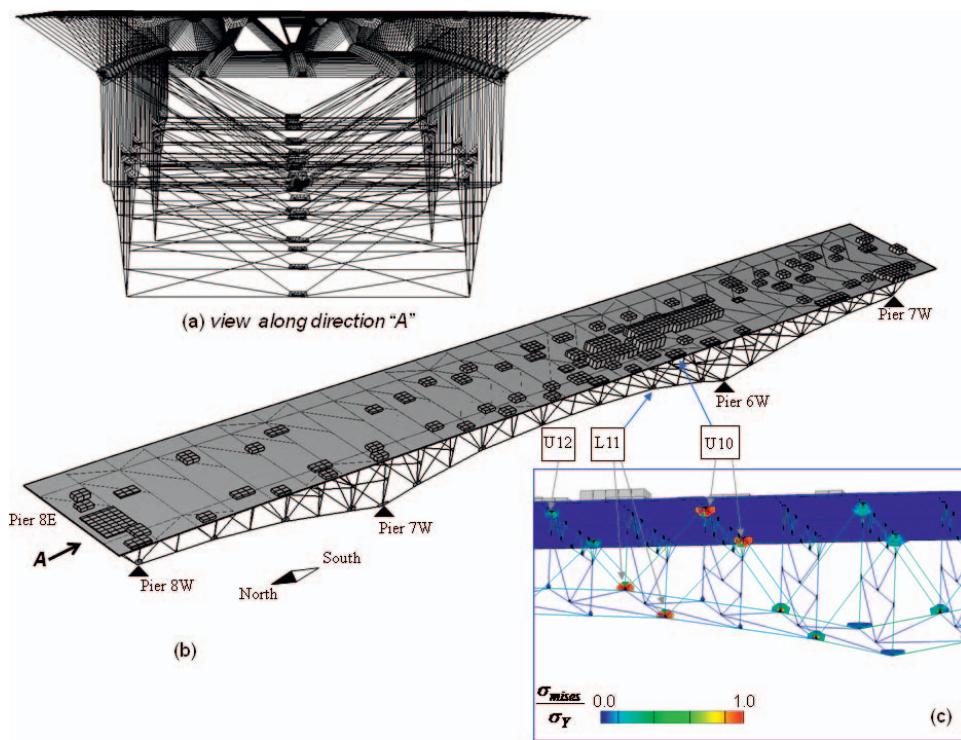
Fig. 2. (Color) Global 3D finite-element model of the I-35W bridge: (a) view of the model from north; (b) overview of the model, where the deck live load at the moment of collapse is modeled by brick finite elements; and (c) the computed stress contours, showing that gusset plates U10 and L11 had the highest stress under the deck load

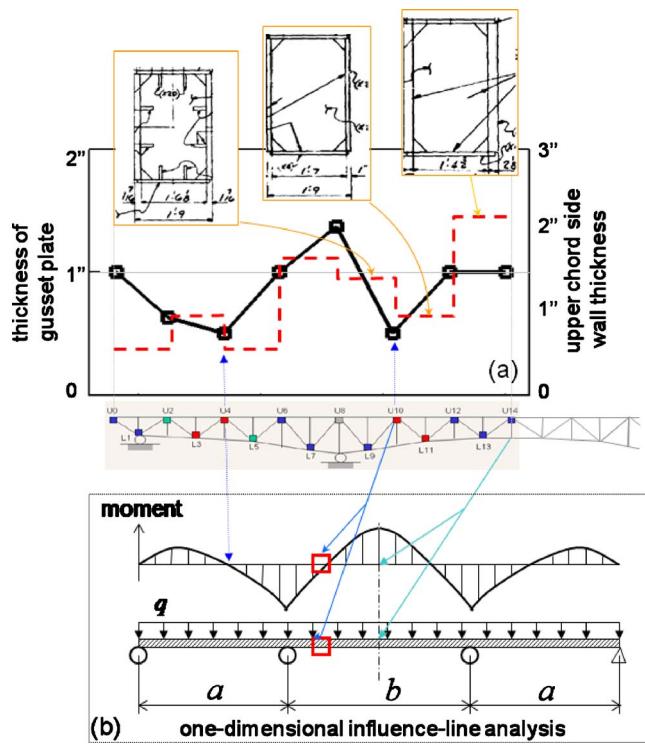
Fig. 3. (a) Thicknesses and locations of I-35W gusset plates (the empty squares connected by solid line) and the side-wall thicknesses of the upper chords (dashed line); (b) one-dimensional influence-line solution for a three-span bridge model that was used to explain I-35W design (Hao 2007). A consistency can be found between the distributions of these thicknesses and the bending moment solution.

NTSB's investigation revealed that the failure of the undersized U10 gusset plate initiated the bridge's collapse. Gusset plates U10, L11, and U4 (see Fig. 3) were only 0.5 in. thick, whereas other gusset plates were 1 in. or greater. To explore the reason why the gusset plates were undersized, Plot (a) of Fig. 3 shows the locations of the gusset plates (represented by the squares connected by solid lines) and the thicknesses of the upper chords' side wall (the dashed lines). Plot (b) of Fig. 3 demonstrates the one-dimensional influence-line solution for the three-span bridge model that was used to explain the original design (Hao 2007). By comparing the thickness distributions of these structural components with the bending moment solution, one can find an obvious consistency. This fact reveals that the original design, at least for the main frame gusset plates and upper chords, was based on similar one-dimensional models. By contrast, Plot (b) of Fig. 4 displays the stresses in the western upper, lower, and diagonal main-frame truss members under the load at the time of the collapse, which demonstrates that the principal stress in the diagonal members was about four times higher than in the upper chords near the U10 gusset plate. Consequently, the forces from the diagonal members dominated the stress state in the gusset plate.

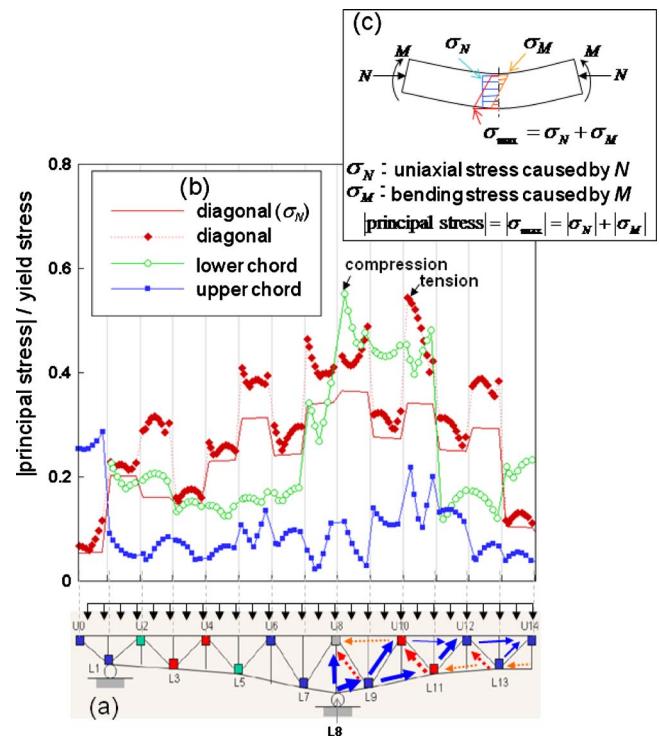
The computational results in Plot (b) of Fig. 4 can be summarized as following: (i) the stress levels in the diagonal and lower chords were generally higher than in the upper chords; (ii) two stress peaks occurred: a tension peak in diagonal member U10-L11 near gusset plate U10 and a compression peak in the lower

Fig. 4. (a) One-half of the main truss frame with an illustration of the load path in the center span; (b) the corresponding amplitudes of the stresses in western main frame under the collapse load. Here, the $|\text{principal stress}|$ can be either the first principal stress (tension) or the third principal stress (compression) but with the maximum amplitude.

chord L8-L9 near gusset plate L8. According to design drawings, the node L8 was reinforced by a 1-in.-thick gusset plate overlapped by another small 0.625-in.-thick cover plate. This analysis focuses on gusset plate U10 and the diagonal members. (iii) By comparing the uniaxial stress, σ_n , in diagonal member (represented by the solid line) and its principal stress (the solid diamonds connected by a dotted line), the difference between the two stresses was the contribution of the bending moment. In the area around gusset plate U10, the contribution was about one-third of the total stress. Plot (a) of Fig. 4 represents one-half of the main frame of the bridge with an illustration of the load path; the solid arrows demonstrate the resistance flow from the supporting pier to the upper chords and the dashed arrows represent the tension flow that has one peak on the lower chords at the middle of the center span and another peak on the upper chord just above the supporting pier. The gusset plates with a distance to the supporting pier between one-sixth and one-third of the total center span length, like U10, are the pivots that transfer deck-load and center-span weight to the lower chords and piers through diagonal members. One-dimensional influence-line models only give estimates of the stresses in the upper and lower chords and are generally unable to provide information of the force flows in the diagonal members. The amplitudes of the forces in each truss member under different load conditions were analyzed (Hao 2007). As indicated in Gee (2008), more detailed analysis is necessary for design and rating of this kind of steel bridges.

As indicated in Fig. 4, the diagonal truss member U10-L11 carried the tension stress with the highest amplitude among all of the main truss members. This stress was corresponding to the weight of the middle part of the central span and the deck load above. In that plot, the low-stress amplitude in the upper chords attached to gusset plate U10 implies that these horizontal members contributed limited load capacity to the gusset; therefore, the majority of the vertical load on this node was balanced by the compression force and bending moment carried by the diagonal member U10-L9. It seems as if the designer noticed this high compression because in the original drawings of the U10-L9 member, there was a box beam with a side-wall thickness of 2 in. and a section area larger than any of the other truss members

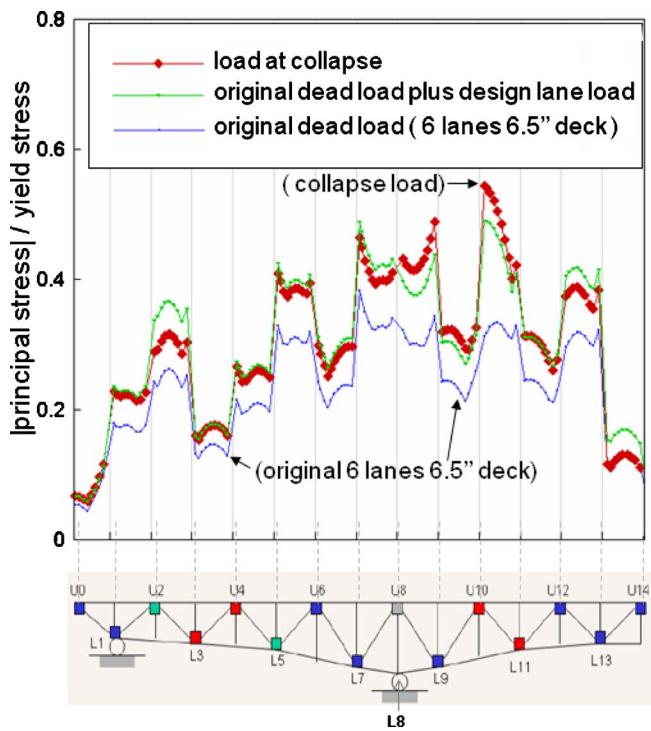
Fig. 5. Principal stress in truss diagonals under three load conditions which show that the peak stress appears at the location near gusset plate U10 when the deck load is present

6.5-in.-thick deck, the dead load plus the design lane load, without the design truck load, and the load at the time of the collapse. This plot demonstrates that the peak stress under the collapse load is about 10% higher than the peak stress in the area near gusset plate U10 under the second load condition. Fig. 6 represents the stress distribution in the vertical truss just beneath the western

The results plotted in Fig. 5 suggest that under the original dead- and design-lane loads, the maximum principal stress in the diagonal member near gusset plate U10 was about half of the yield strength of the steel. On the other hand, elastic stress concentrations in the attached gusset plate could be more than double that of the stresses in truss members. These facts imply that the undersized gussets could have been partially yielded, locally buckled, or both, when the bridge was at the designed service load long before the collapse. The bowing of the gusset in Fig. 10 is evidence of this possibility.

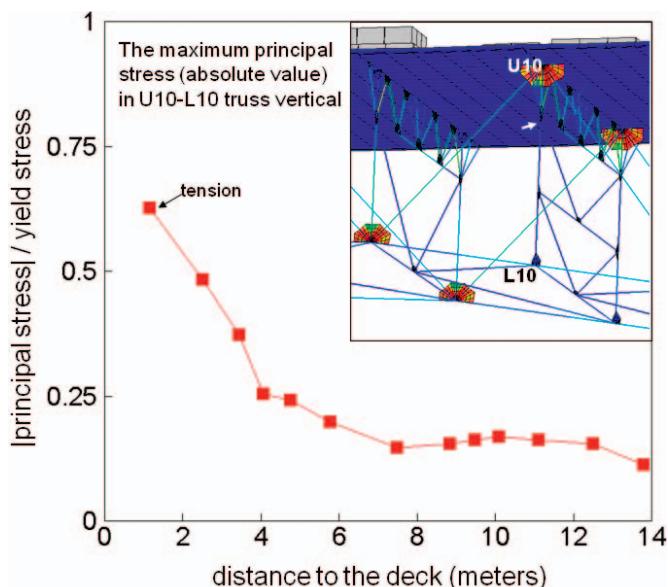
Fig. 6. (Color) Principal stress in the vertical truss between gusset plates U10 and L10. The amplitude rises about three to four times within the member between the floor truss joint (indicated by the white arrow) and gusset plate U10.

gusset plate U10 under the collapse load, demonstrating the rising amplitude at its end attached to the gusset. Displayed in Fig. 7 are the stresses in the members of the floor truss frames above nodes U10 and U11 under the collapse load. These frames were just beneath the stock-piled construction materials when the bridge collapsed. In both locations, the maximum compressive stress occurred at the diagonal members that connected the top floor trusses and the western main frame vertical truss.

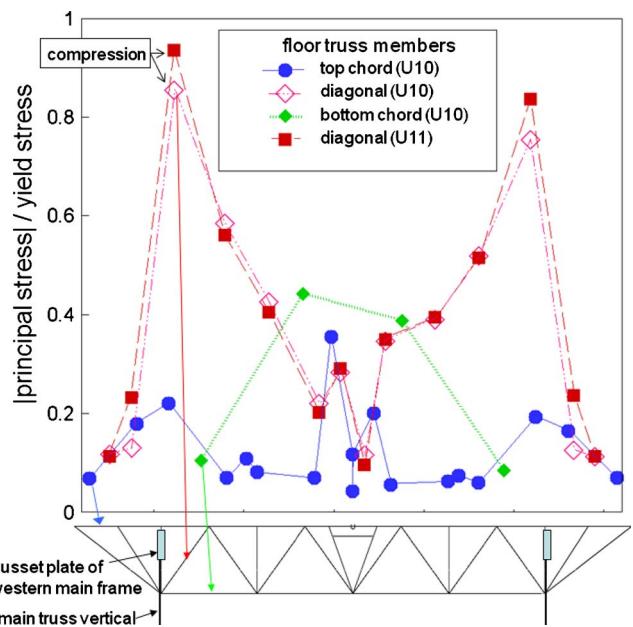
Fig. 7. Stresses on the floor truss frames above nodes U10 and U11 under collapse load. The peak stress occurs on the diagonal truss member between the top floor truss and the main truss vertical member, which caused the elevated stress in main frame truss vertical member (see Fig. 6).

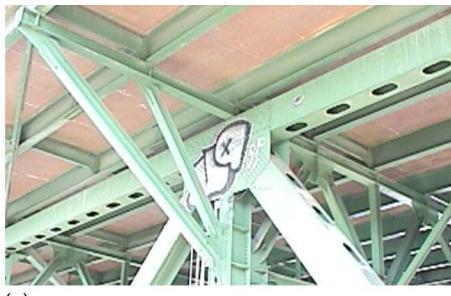
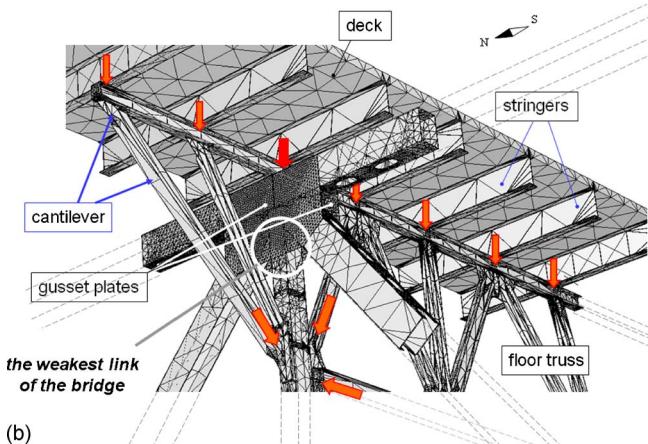
Fig. 8. Design of the nodes that connect floor trusses and main frames: (a) the node U10; (b) finite-element model

According to Figs. 4–7, the principal stresses in the truss members were generally below the steel yield strength under the collapse load. On the other hand, remarkably high stresses can be found on the ends of the trusses attached to the western gusset plate U10. Fig. 8(a) demonstrates the connection between the floor truss, cantilever, and main frame trusses within the triangular area centered at gusset plate U10. Fig. 8(b) shows the corresponding finite-element model using 3D tetrahedral elements. This design enabled the bridge to support a wider deck but required stronger gusset plates to sustain the two associated load paths: compression from the deck onto the plate's top and down pulling from the vertical truss to its bottom. The particular design of the floor truss frame in I-35W also induced lateral forces through the vertical truss to the gusset plate.

2. The inadequate gusset plates’ thickness, in conjunction with the inadequacy in the particular design of the upper node that connected the floor truss and main frame, essentially removed the local redundancy of each truss cell (see Fig. 8) in this bridge and caused high localized stresses in these gussets.

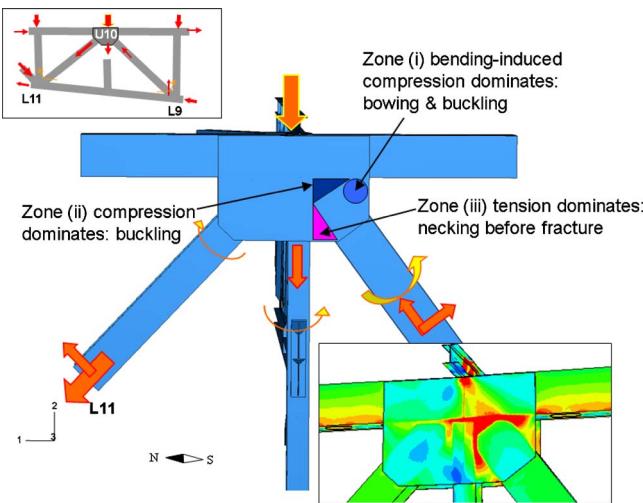
Fig. 9. Illustration of the forces and moments around gusset plate U10, which produced three stress concentration zones on the side with the compressive diagonal member

Fig. 9 illustrates the stress state of gusset plate U10 computed by the submodel in Fig. 8(b). When a diagonal member introduces compressive force, stress distribution on the gusset can be characterized by three zones: Zone (i), the area between horizontal and diagonal members where the compressive stress induced by the bending moment dominated and it is this compression that may have caused bowing and buckling; Zone (ii), the triangular area between the ends of the horizontal, vertical, and diagonal members where buckling could be a dominant failure mode; and Zone (iii), the area between the diagonal and vertical truss members where a tension stress state might dominate. The bending-moment-induced tension along the horizontal direction and the pulling from the vertical truss caused the downward tension.

Under this condition, the scenario of the collapse could be as follows: the biaxial tension in Zone (iii) induced plastic deformation that resulted in thickness reduction and necking. Such a deformation pattern is compatible with a simultaneous bowing in Zone (i). The latter might trigger a buckling in Zone (ii). These mechanisms, in conjunction with the lateral force induced by the diagonal floor truss, promoted movement of the diagonal member U10-L9, which tore the gusset plate off and transferred the vertical compression to the vertical truss member U10-L10. The latter was a redundant component in the design and, therefore, had a much smaller section area and moment of inertia. It buckled immediately due to the high down-pulling load imposed on the gusset by the diagonal member U10-L11. This led to a complete failure of node U10, followed by the fractures of the gusset plates L11 and U11, and, finally, the subsequent collapse of the bridge.

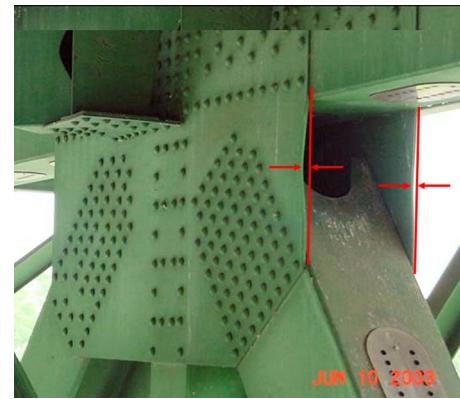
Fig. 10. Bowing at gusset plate U10 before the collapse [National Transportation Safety Board (NTSB) 2008d]

This scenario is evident by the findings of National Transportation Safety Board (NTSB) (2007b,c, 2008a,b,c,d). As demonstrated in Fig. 10, bowing in the aforementioned zone (i) caused by bending moment was noticeable by this 2003 photograph. In Fig. 11, the destroyed pieces of gusset plate U10 reveal the necking along the horizontal direction near the bottom of Zone (iii) and the tension-induced fracture in the upper-right portion of the image, or the ligaments between the rivets. Fig. 12 shows the wreckage of the entire bridge that was reassembled by the National Transportation Safety Board (NTSB) (2008d). Almost all of the vertical trusses attached to nodes U9, U10, and U11 were severely damaged within the triangular area demonstrated in Figs. 8 and 9.

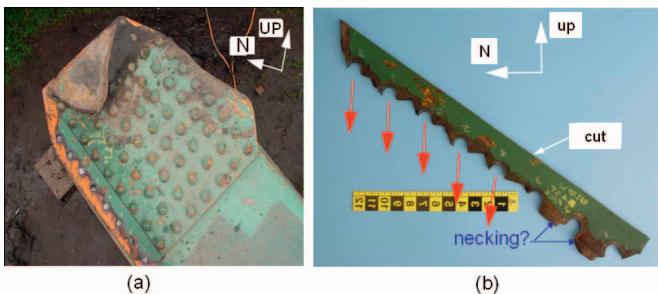
Fig. 11. (Color) Fractography of gusset plate U10 [National Transportation Safety Board (NTSB) 2007c]: (a) the diagonal truss member U10-L9 after it tore off the gusset; (b) a cut from the gusset, where the red arrows indicate the direction of tension, which shows the downward-pulling and horizontal tension-induced necking; where “N” refers to north

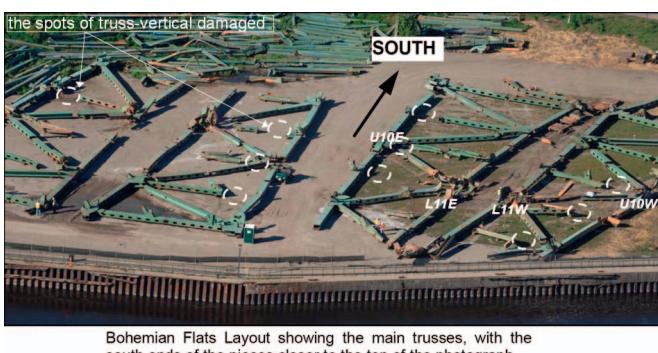
Fig. 12. (Color) This NTSB photograph [National Transportation Safety Board (NTSB) 2008a,b,c,d] shows that many vertical trusses were severely damaged within the triangle area defined by Fig. 8
