Research Report

## **A Preliminary Analysis of the Bridge 9340 Collapse at August 1<sup>st</sup>, 2007 and Some Suggestions**

S. Hao Ph. D.

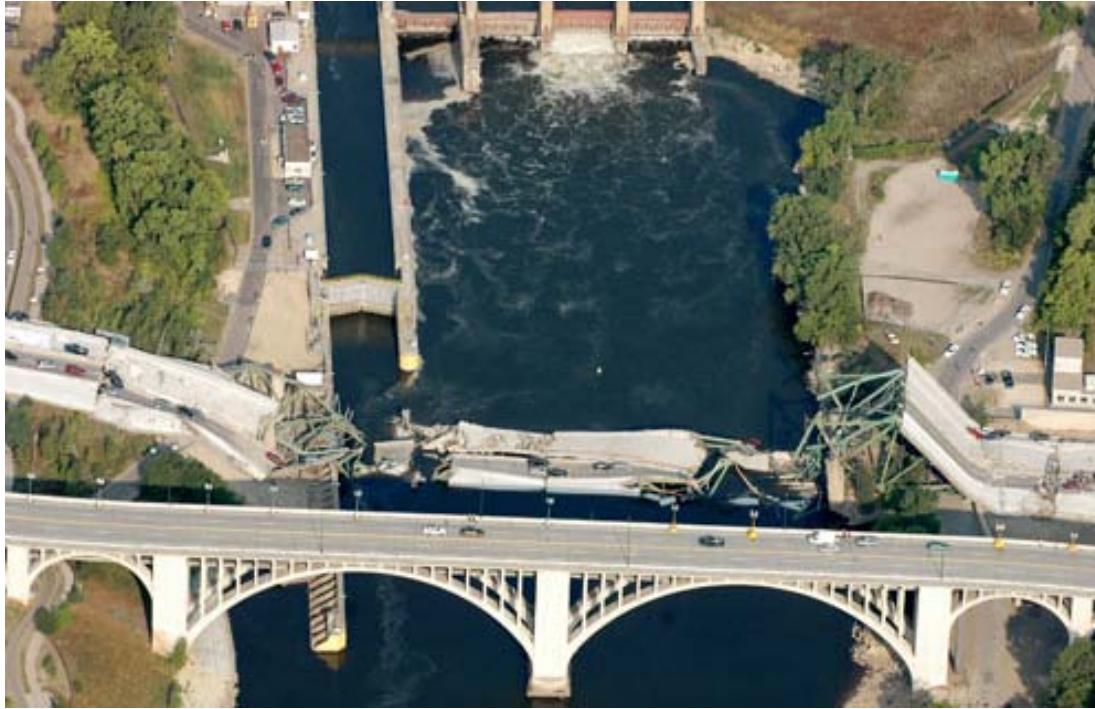
Fig. 2 Debris of the wrecked bridge 9340, after the collapse at August 1<sup>st</sup>, 2007.  
(picture collected from Chicago Tribune)

By comparing the failure pattern in Fig. 10 with the debris of the wrecked bridge in Fig. 2, it looks like that the collapse of 9340 bridge is triggered by defects-induced material's failure at several locations that do not necessarily match the plastic hinges showing off in the structural failure in Fig. 10a. These distributed material's failure sites severely reduced the capacity of the bridge against its load and, leading to subsequent structural failure with different mode. There are three evidences to support this conclusion: (i) The actual live load at the accident was within the window of the tolerance [2], although the average traffic flow constantly surpassed original estimate. (ii) Previous inspection did detect existing defects. (iii) The preliminary observation, e.g. Fig. 2, shows that the distributed debris exhibit large scale damage and deformation in many truss members around the piers of main span, instead of concentration to certain localized plastic hinges.

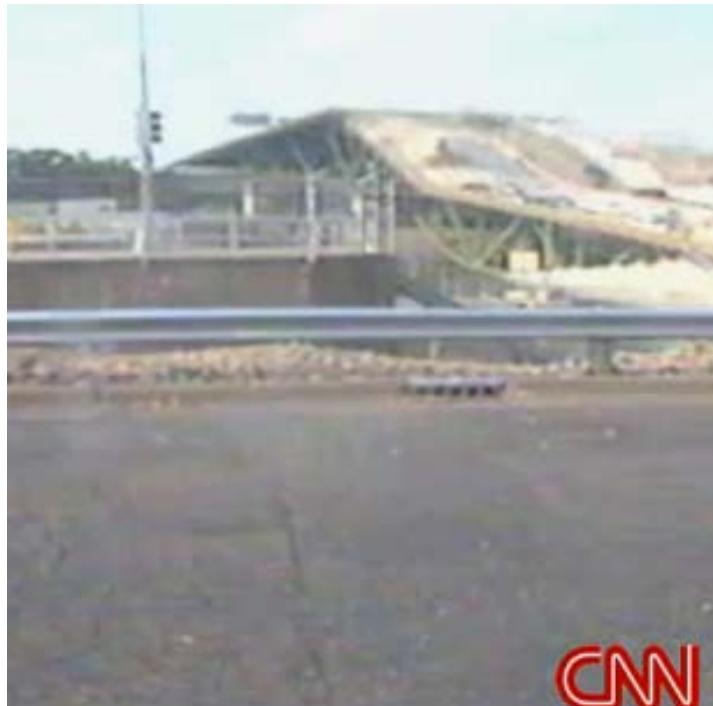
Fig. 16 The instance that main span fell into water

\* This section identifies that the failure started at the south end around the pier. Fig. 16 is taken as the evidence for this conclusion; which essentially matches the NTSB's findings because of the heavy surface load there. However, due to imperfect information the author could have at the time, in the text the "pier 5" has been written as "pier 7"; also the prime attached to a node's symbol should be reversed, i.e.  $U_{9E}'$  should be  $U_{9E}$  and vice versa, according to NTSB's convention. These minor confusions have no effect on the obtained conclusions. (noted by Su Hao at May 14, 2008)

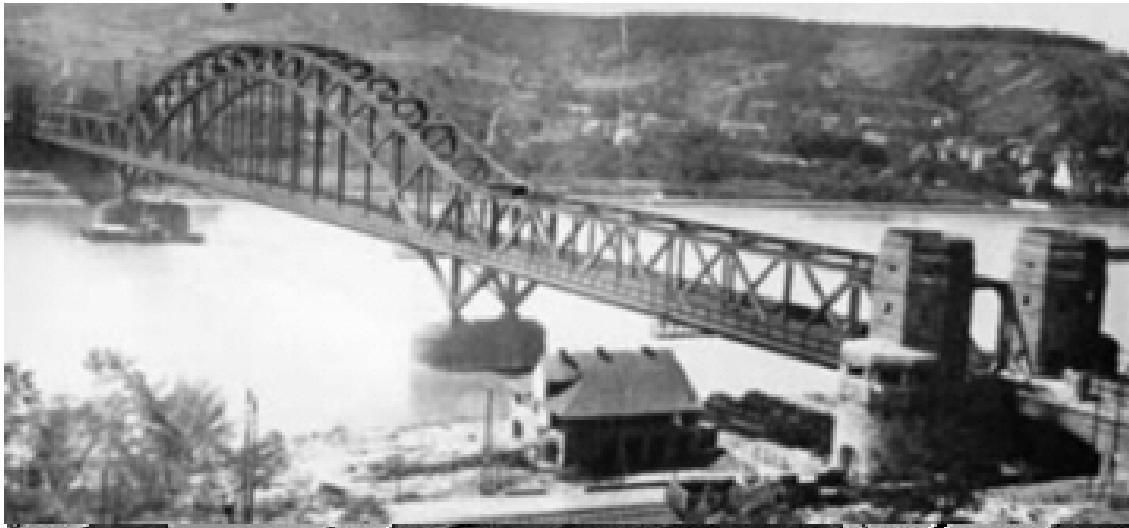
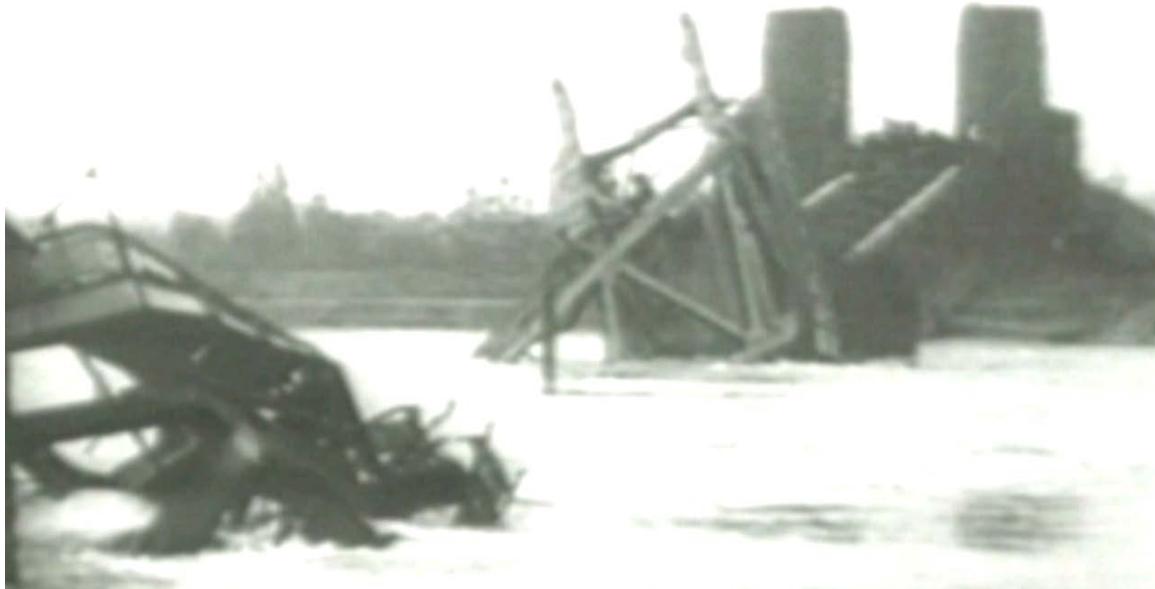
(a) The three-pan upper trussed bridge on the Reihen, Western Germany; built at 1919  
after the name of General Ludendorf of Deutch Army

(b) the wrecks of the bridge after it collapsed at 1945

Fig. 17 Historic example: the collapse of Ludendorf bridge of Reihen at 1945  
(photopictures collected from the documentary “Definitive history of WWII, published  
by Brentwood L.L.C. and de.wikipedia.org)

The collapse of Ludendorf bridge on Reihen River of West Germany at 1945 winter may provide some hints for the current analysis. The three-span truss bridge (Fig. 17a) was built at 1919 just after World War I with classical upper-truss design, so the road deck is in the bottom where the peak moment-induced tension presents. It had been captured peacefully by U. S. Army at the beginning of 1945 and 6 large army units passed safely. But then it collapsed without live-load presented. Due to the strategic importance the bridge was heavily guarded by G.I., which excludes the possibility of Nazi's action. According to the photopicture(Fig. 17b) it looks like the middle part initiated the failure. It is speculated that the passed heavy army equipments accelerated the fatigue propagation of some existing defects, the localized material's failure caused the following structural failure since no active load when the accident occurs. Ten years ago the author of this report visited the ruins of the bridge. Now there is a status to symbol the corporation between U. S. and West Germany Arms in Nato.
